TN no. N-1468

title: FLANGED ACRYLIC PLASTIC HEMISPHERICAL SHELLS FOR
UNDERSEA SYSTEMS - Static and Cyclic Fatigue Life
Under Hydrostatic Loading

author: J. D. Stachiw and R. Sletten

date: January 1977

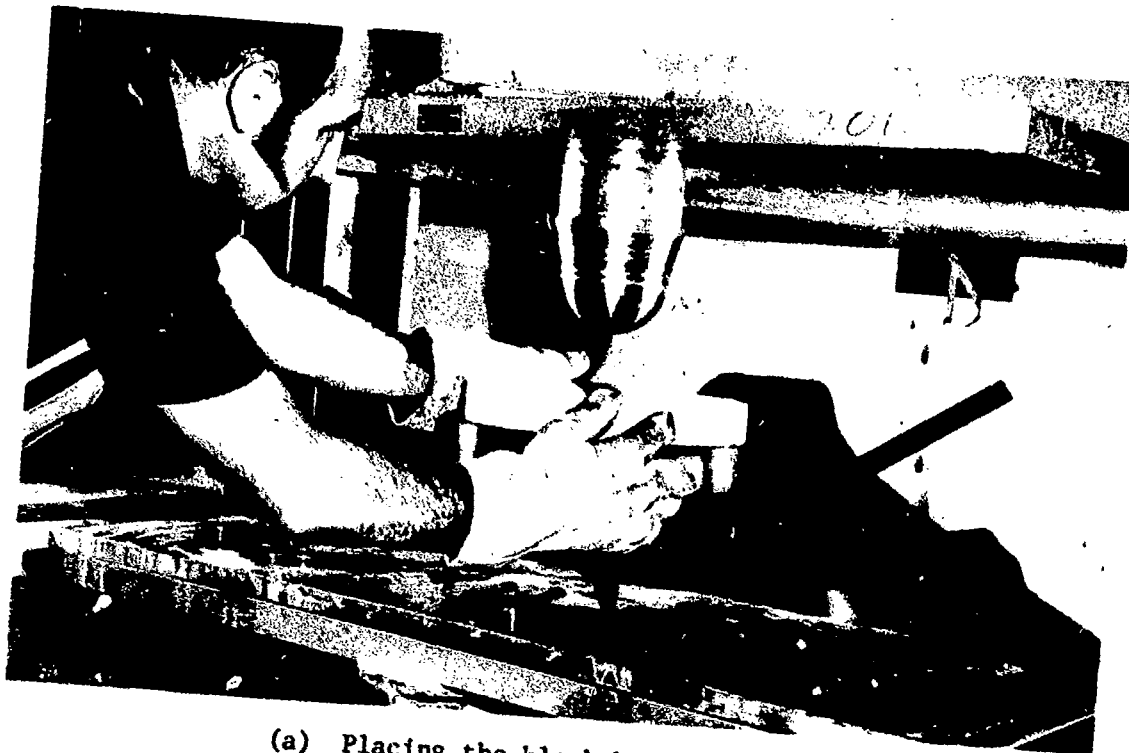
(a) Placing the blank between dies.

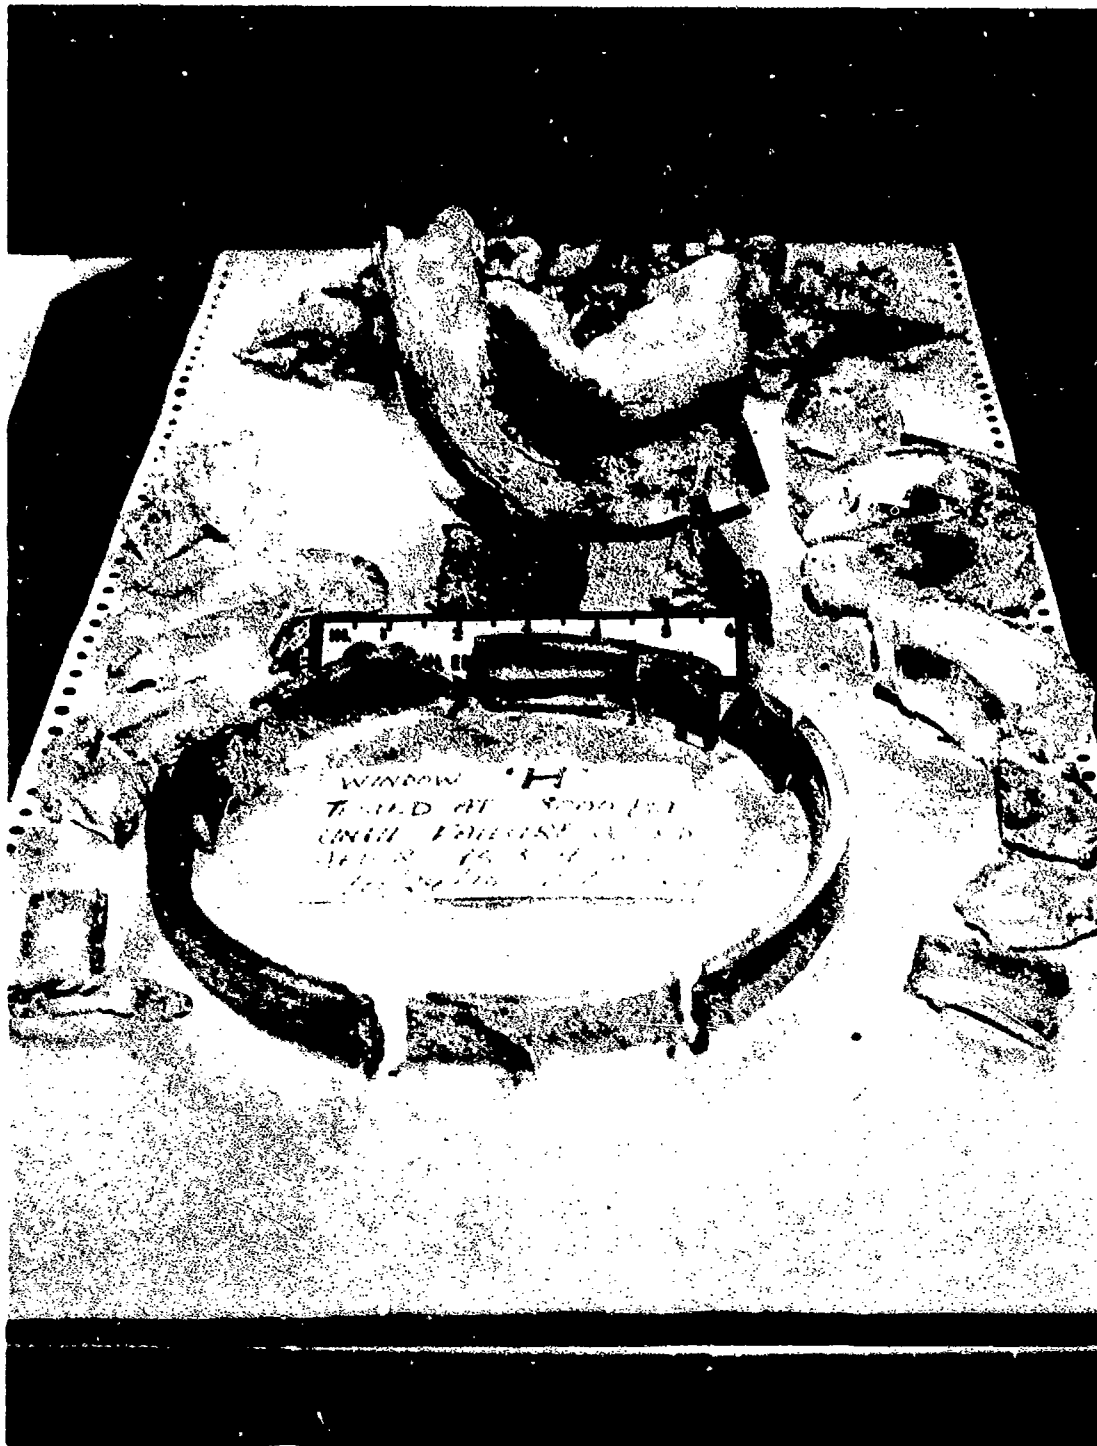
Figure 18. Window H, Type I after 153 hours of sustained pressure loading at 8,000 psi; note the separation of flange.

In all cases of failure under long-term loading, the failure was catastrophic, resulting in heavy fragmentation of the windows (Figures 18 through 26). Typically, the force of implosion blew a hole in the window dome producing grain size fragments of the blown-out material. The rest of the dome stayed relatively intact, although it was always fractured radially into several pieces (Figure 21). In addition to the radial fractures, a large number of in-plane fractures occurred. The number of in-plane fractures increased toward the interior surface of the window. The outer 1/4 inch or so of the wall was usually not laminated (Figure 24).

After implosion, the flanges were found to be separated from the main body of the windows. In Type I windows, the separation was all around the flange (Figures 18 and 19), while in the Type VI windows the separation was partial (Figures 20 and 21). The flange separated from the dome generally before implosion occurred, as demonstrated by window U whose long-term loading was terminated prior to implosion (Figures 22 and 23).

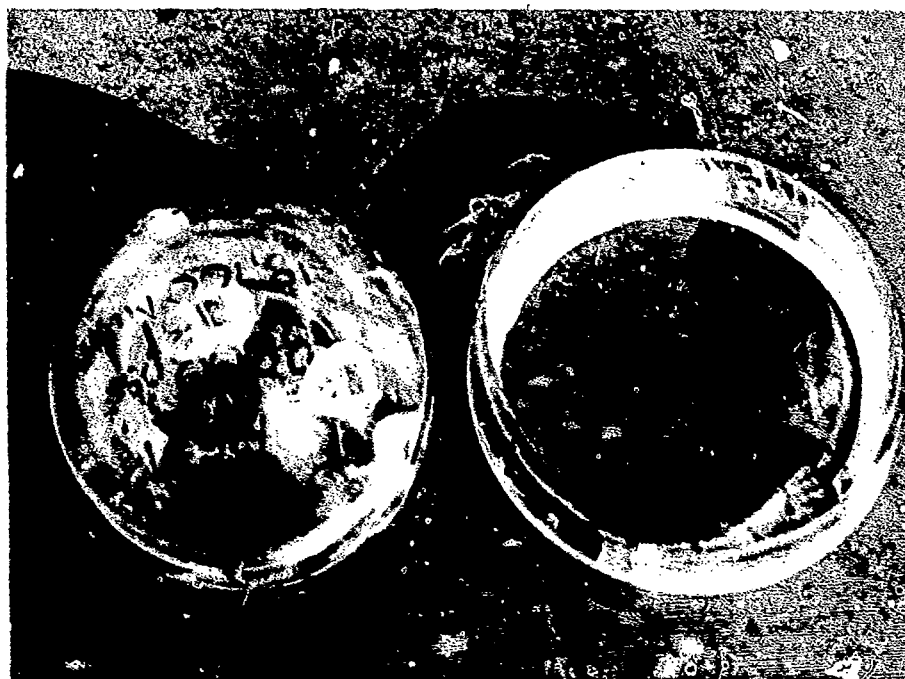
Figure 23. Same window as in Figure 22; note that the separated flange remains intact indicating that (a) the circumferential cracks initiate sooner and propagate faster than radial cracks and (b) the separation occurs before extensive plastic deformations occur.

At 8,000 psi, window U lasted 312 hours without imploding; the window was, however, severely damaged. The flange had separated and the bearing surface was deformed into a conical surface which had several large cracks in it (Figures 22 and 23).

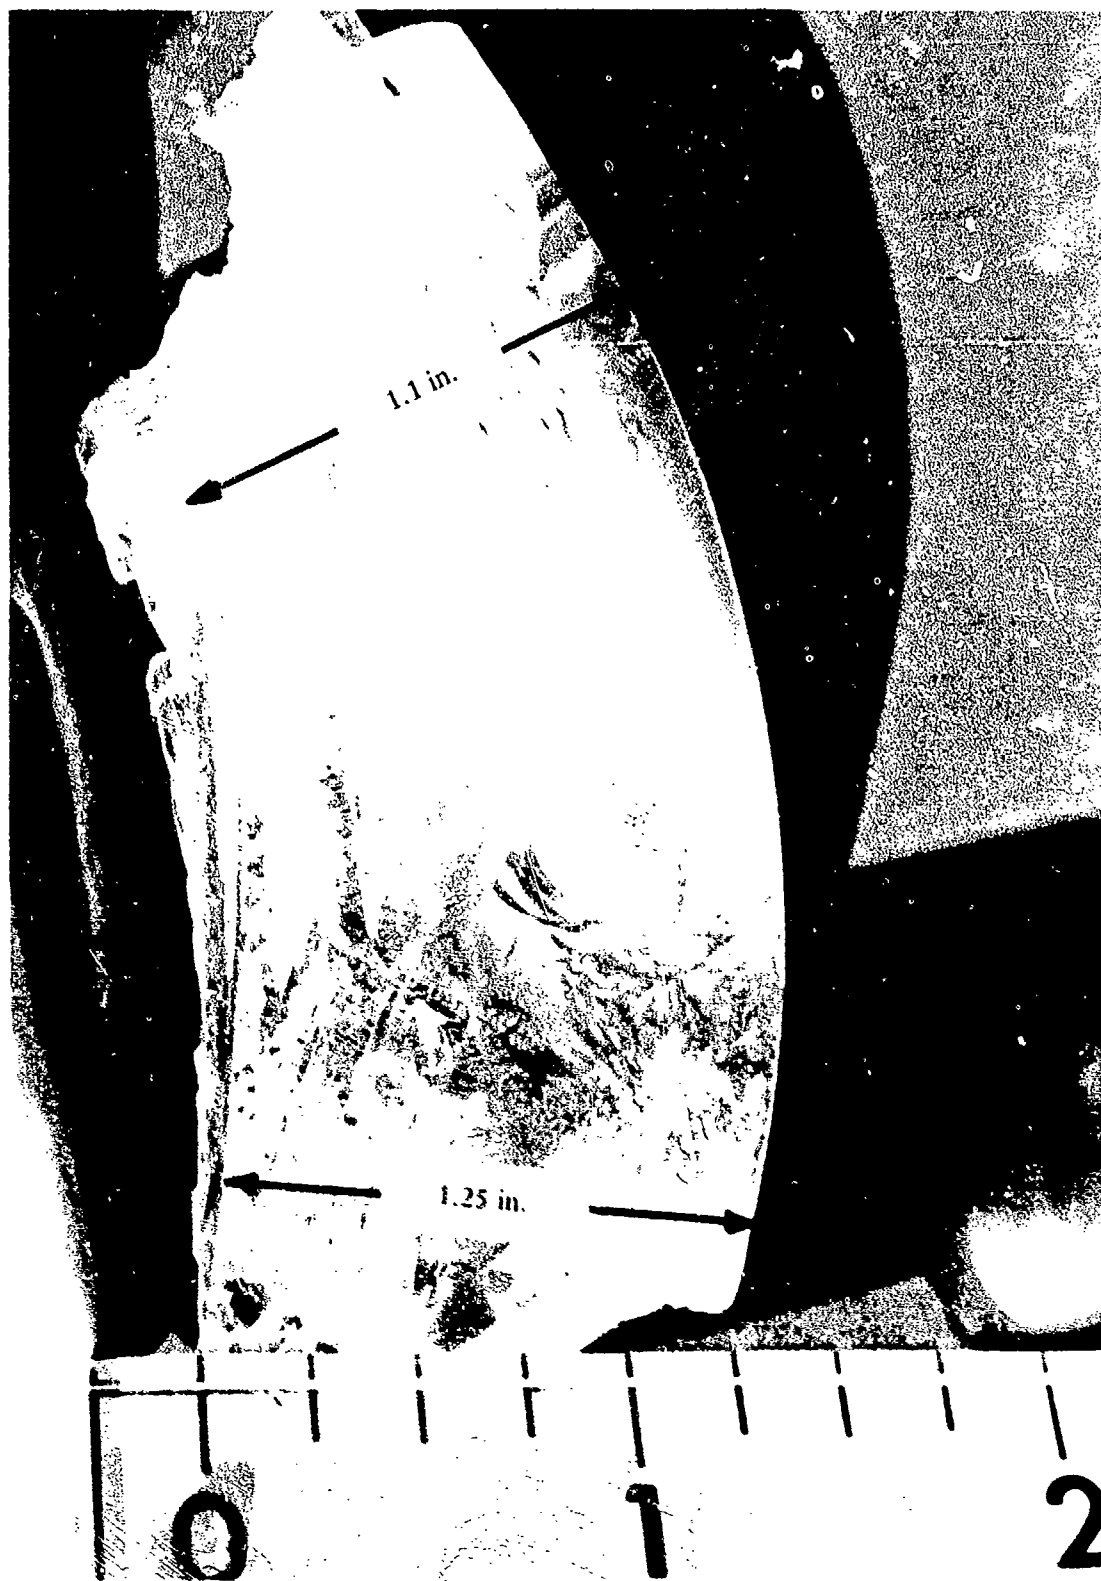
Figure 26. Window H, after 154 hours of sustained pressure loading at 8,100 psi; note the increase in wall thickness of the window near the flange due to plastic flow of acrylic under biaxial compression.

The window flange bearing surfaces fractured during the tests in the circumferential direction (Figure 25). The heel (inside edge) of the flange was permanently deformed, resulting in the formation of a sharp edge that contrasted sharply with the original well-rounded-heel geometry (Figure 25). The deformed fragments also showed that the thickness of the wall above the flange permanently increased by about 25% of the original thickness (window J). A similar increase was observed in the width of the flange measured between the inside edge of the heel and the O-ring groove. The height of the flange, however, was unchanged (Figure 25). These observations were further confirmed by a study of the fragments of window P (Figure 26).

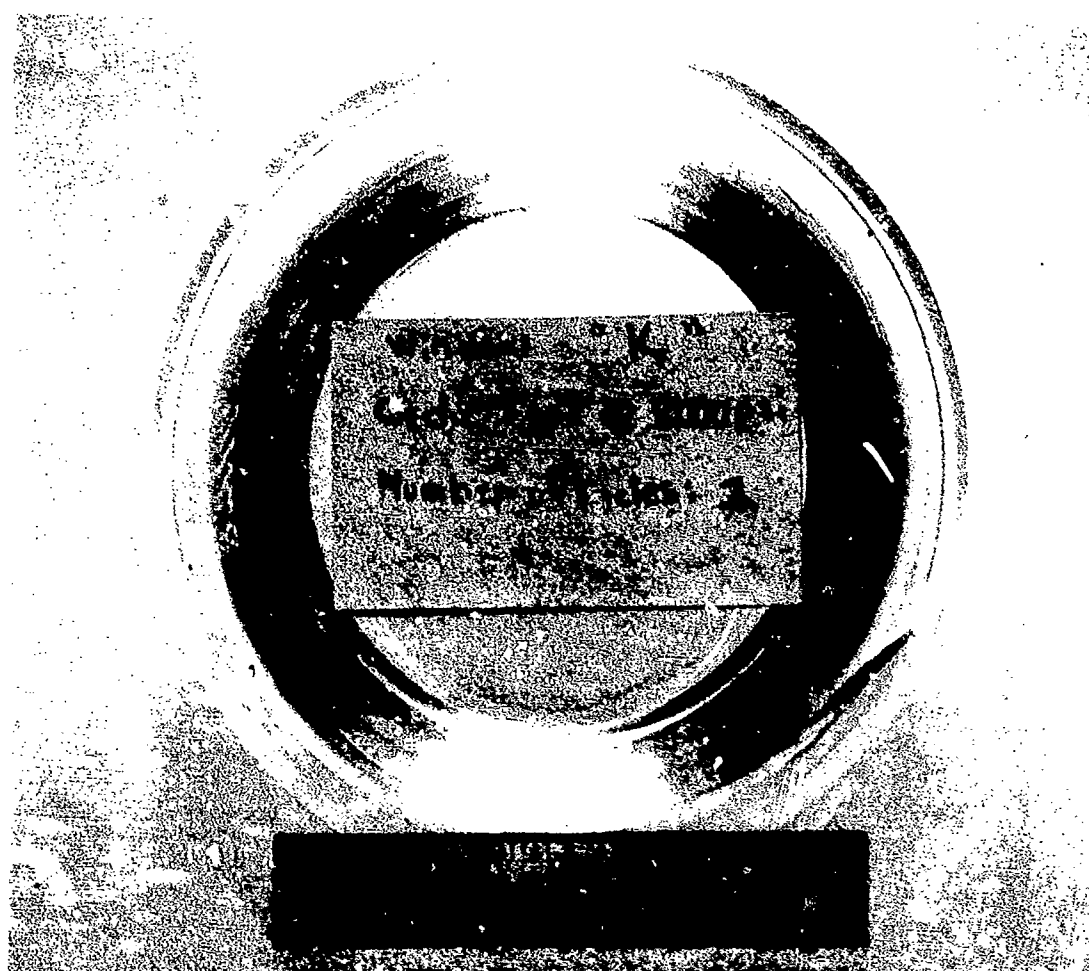
Figure 44. Typical cyclic fatigue cracks on the flange bearing surface; window K, Type 1 after one standard pressure cycle to 8,000 psi. Note major circumferential crack between the heel of the flange and the O-ring groove.

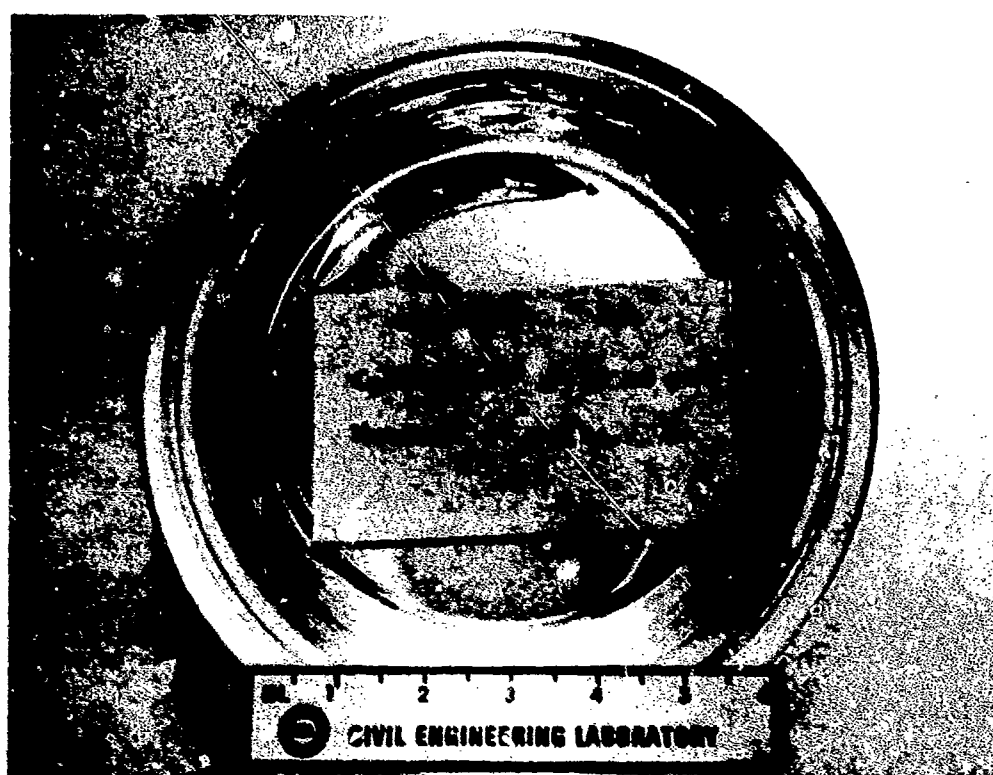
Figure 46. Typical cyclic fatigue cracks on the flange bearing surface; window BB, Type VI after two standard pressure cycles to 8,000 psi. Note many circumferential cracks between heel of the flange and O-ring groove.

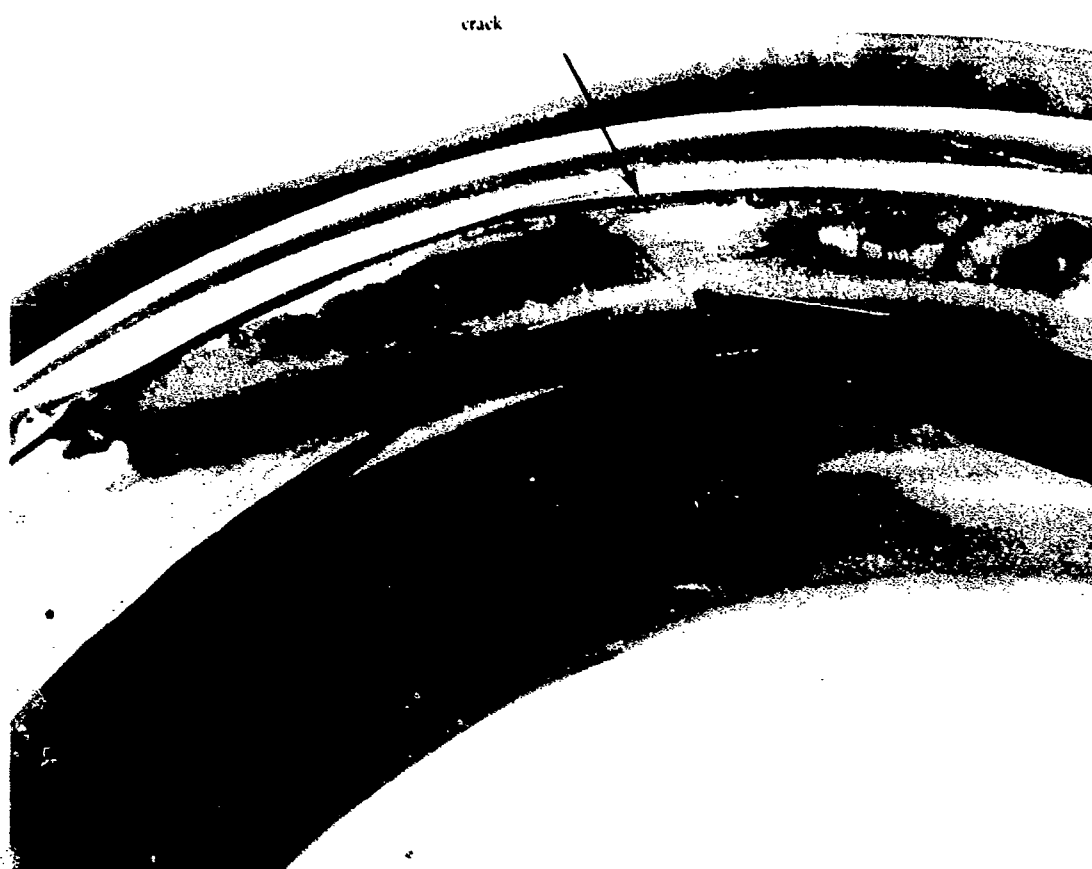
Figure 54. Typical cyclic fatigue circumferential cracks on the bearing surfaces of Type I flanges that cause the window to leak after a few pressure cycles; window K, Type I after one standard pressure cycle to 8,000 psi.
